That’s the moment a lot of bad **AC lineset** decisions get exposed.

## #1. Recurring Low Charge Calls — Pressure Loss Usually Starts in the Refrigerant Line Set, Not the Equipment

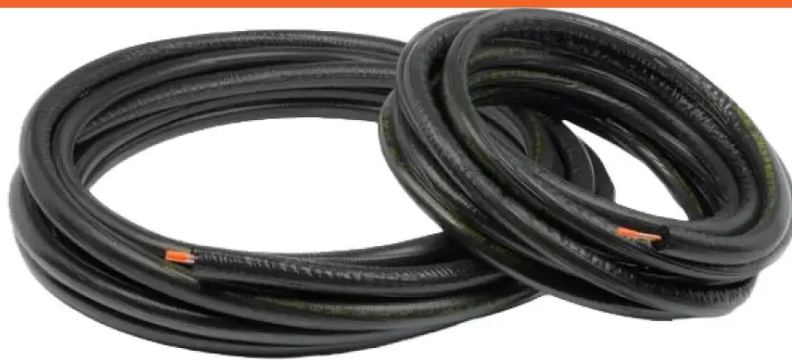
*Mini-Split Copper Line Set*
